ATTACHMENT F: SAFETY BEST PRACTICES

This attachment aims to provide the most current understanding of safety best practices for stationary energy storage systems with a focus on lithium-ion batteries. We draw from industry studies, lessons learned from specific safety-related events, and expert opinion to summarize safety risks and remedies associated these installations. Although this attachment (and most of the industry's codes and standards we reference) focuses on lithium-ion batteries, many of the best practices we outline are translatable to other energy storage technologies as they reach commercial scalability.

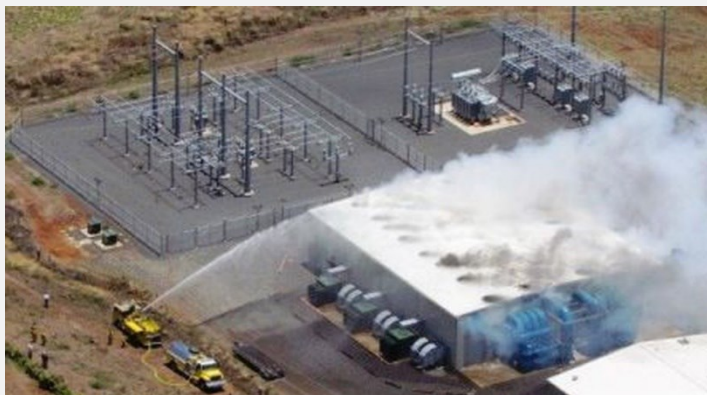
Figure 2: Event at Kahuku Wind Farm—August 2012.

Exact cause of the August 2012 fire was not publicized, although first alarm activation and visual evidence indicates fire origination within an inverter cabinet. Cause of the first two fires in April and May 2011 was linked to undersized capacitors contained in the battery system's inverters and led to litigation among the involved parties. The battery developer Xtreme Power had a significant portion of its business in Hawai'i and it filed for Chapter 11 bankruptcy protection in January 2014.

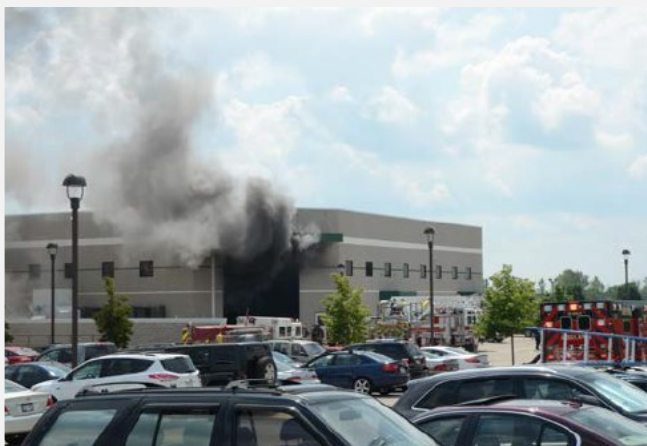
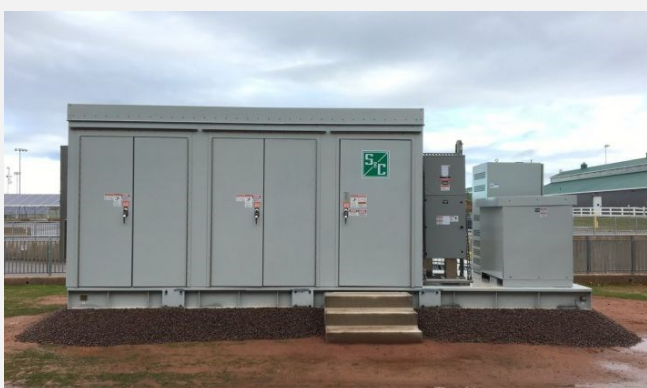
During Event

In August 2016 a fire occurred at the facility involving a partially-assembled system of lithium-ion batteries within its shipping container (Figure 4). The energy storage system's fire suppression and containment system was nonfunctional as it was only partially assembled. Over 20 fire departments were involved, apparently due to the severity of the fire and weather conditions. Smoke was observed upon arrival at the site. One firefighter injury was initially reported although not part of final descriptions of the event. The Franklin Fire Department estimated damages on the order of \$3 million.

S&C's final public assessment of the situation included emphasis on a need for better information and training on fighting battery fires, noting that material safety data sheets are not enough. The company also outlined five elements of their approach to safety:

- Intelligent controls (their battery and power conversion system);
- Protective devices (fuses, AC circuit breakers, DC circuit breakers);
- Fire suppression systems;
- System design (power conversion system, battery components and systems, compartmentalization, and containerization); and
- Container.

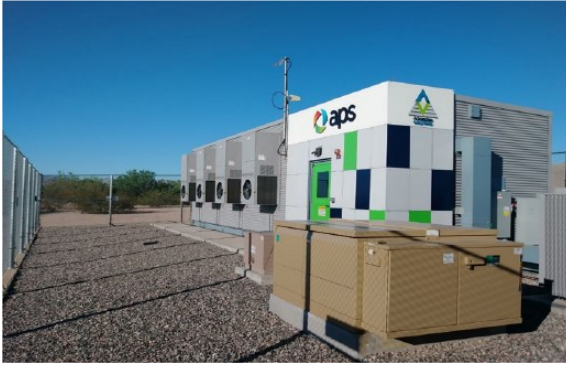
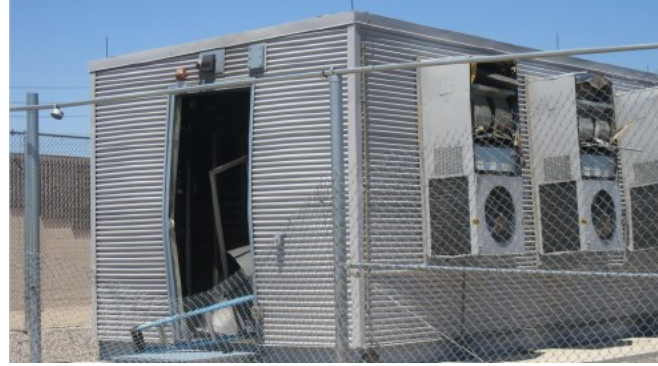
Post-Event*Figure 5: McMicken Battery Energy Storage System event—April 2019.*

In April 2019, after about 2 years of operations, the system was destroyed by rapid thermal runaway over the course of 3 hours followed by an explosion. The system's temperature monitor, laser-based Very Early Smoke Detection Apparatus (VESDA), and Novec 1230 clean agent gas fire suppression system reportedly operated and responded as designed. A passerby reported smoke about 45 minutes after VESDA registered an alarm condition and the Surprise Fire-Medical Department was dispatched. At about the same time the battery developer (Fluence) and APS apparently had notified authorities. The first fire engine arrived about seven minutes later (at 5:49 p.m.). The Fire-Medical team observed a toxic smoke emanating from the battery storage facility and called for backup. About 30–40 minutes later the Peoria Fire-Medical Department's HAZMAT team arrived. The HAZMAT team entered the fenced area several times to take readings and assess the situation. About 1.5 hours later (at 8:01 p.m.) they opened the door to the container and an explosion described as "a jet of flame that extended at least 75 feet outward and an estimated 20 feet vertically" severely injured four members of the HAZMAT team. Additionally, four members of the Fire-Medical team plus one officer from the Surprise Police Department were sent to a hospital for overnight observation for chemical exposure. Post-event assessments and cleanup at the site were particularly difficult as the storage system was at a high (90%) state of charge.

APS and LG Chem (the battery manufacturer) each commissioned technical analyses on the event which disagreed on the exact origin of thermal runaway. The APS analysis, conducted by DNV GL, found that thermal runaway was initiated by a voltage drop within one faulty battery cell. The LG Chem analysis, conducted by Exponent, rebutted this conclusion and instead found the cause to be a heat source external to the cells. A third analysis, conducted by Underwriters Laboratories (UL), did not address the topic of initial component failure and instead focused on emergency response and applicable design codes and standards. UL also issued a formal response to the DNV GL report to address inaccuracies it saw in DNV GL's description of the development process, scopes, and test methodologies of UL standards.

DNV GL made several recommendations to address these contributing factors. It also noted a need for a more comprehensive risk management approach that would include input from, and communication among, the battery manufacturer, developer, and procuring utility.

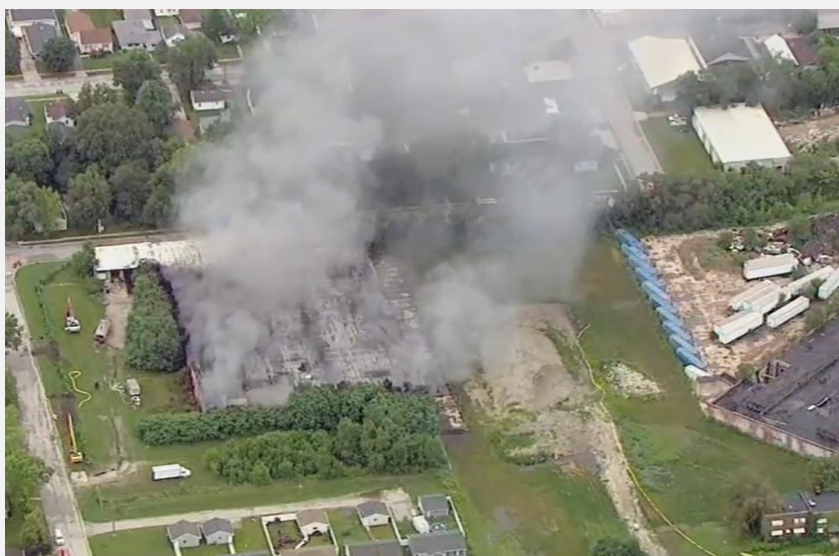
Figure 6: Event at an industrial warehouse in Morris, Illinois—June 2021.

In June 2021 significant thermal runaway propagation in batteries stored in an unlicensed solar and storage industrial warehouse led to a dangerous situation for the surrounding community and emergency responders. The site held approximately 100 tons of batteries.

Smoke and flames were observed over the course of about 1.5 days until contained by concrete, and it took weeks for authorities to declare the site fully under control. About 3,000 homes within a square mile southwest of the site were evacuated for 3 days due to large volumes of toxic smoke emanating from the warehouse. The governor issued a disaster proclamation and The Red Cross supplied food and water to the more than 300 first responders from multiple federal, state, and local agencies and organizations.

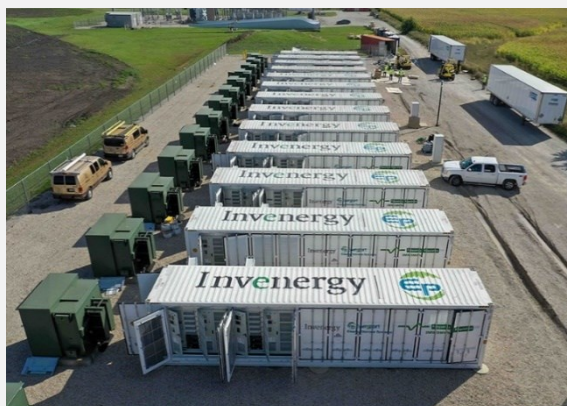
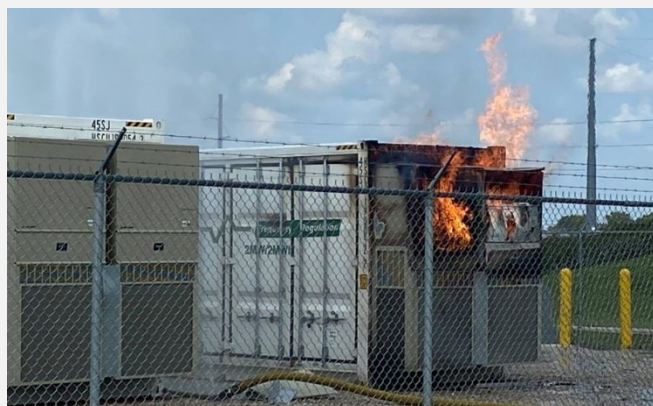
During Event*Figure 7: Grand Ridge Energy Storage Project event—July 2021.*

In July 2021 an incident at the site destroyed one out of eighteen storage containers—or about 2 MW of the project. No persons were reported hurt, no environmental damage was apparent, and the incident received very little press. Fire was observed in the morning, and by mid-evening the visible flames were extinguished by responders. Responders were able to access the interior of the container and they applied water spray to cool the equipment. A responder reported the ability to apply water spray due to the battery’s lithium iron phosphate chemistry (as opposed to the batteries involved in the Morris, Illinois incident—we are not aware of any advantages of LFP under water spray compared to NMC). Invenergy has said it is conducting an investigation.

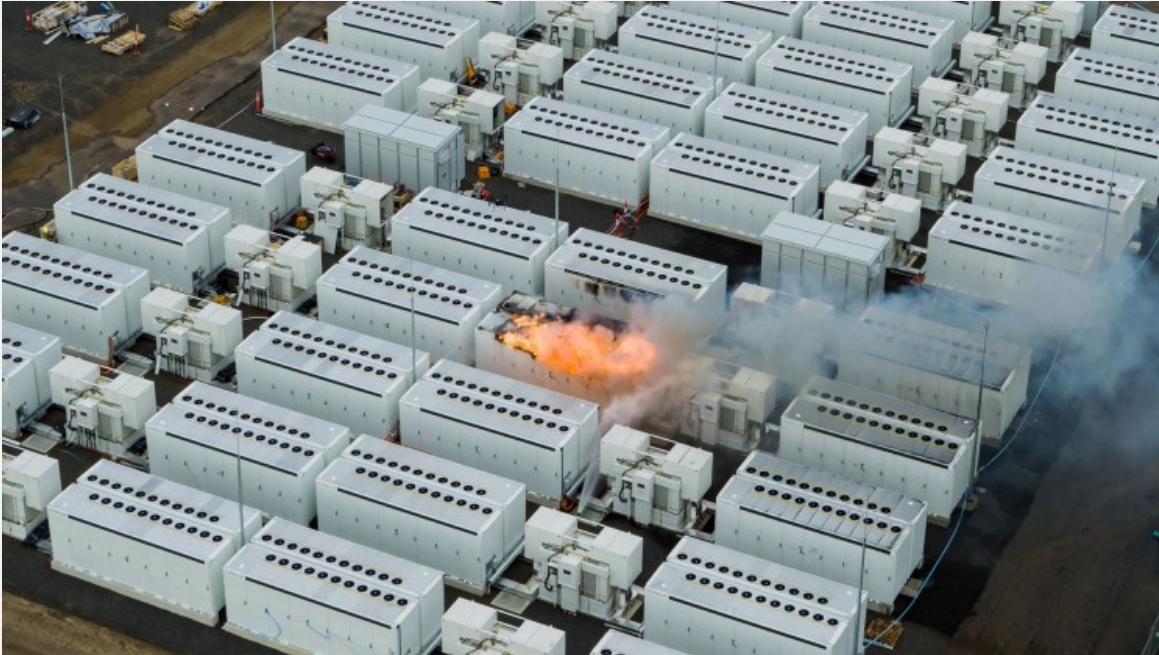
Figure 8: Victorian Big Battery Project event—July, 2021.

In July 2021 two of the 212 Tesla Megapacks were damaged while the project was in the process of initial energization testing. Smoke was initially observed by a site supervisor, then flames were observed shortly thereafter (Figure 8). When responders arrived they applied water externally to nearby exposure equipment and allowed the reactions to self-extinguish. Responders monitored the Megapack temperatures using thermal imaging cameras and drone technology, and in total it took 3.5 days until thermal runaway self-extinguished and the site was declared under control. Energy Safe Victoria (ESV, Victoria's safety regulator) conducted an investigation over the next two months, concluded the event to be a safe failure, and took a number of actions to prevent recurrence. ESV conditionally allowed Tesla to continue energization testing in September 2021. The testing and commissioning process continued and the site officially began commercial operations in December 2021.

The root cause was identified as most likely a cooling system leak in one of the Megapacks. The leak apparently caused an arc fault in the power electronics during the energization testing period, which created a heat spike that initiated thermal runaway in the battery cells. Immediate situational awareness was obscured by various systems not being fully integrated and operational at the time. The Supervisory Control and Data Acquisition (SCADA) system, which reports real-time battery system information to operators, was not functional as it required 24 hours to fully integrate with the project but the Megapacks operated for testing for only 13 hours. Then, when the Megapacks were turned off, the monitoring systems, cooling system, and battery protection system also turned off.

How thermal runaway spread to an adjacent Megapack was of particular concern as the systems were evaluated under UL 9540A testing methods and their spacings were designed to mitigate inter-pack propagation. ESV required this issue to be addressed in Tesla’s investigation. ESV also noted that, “Designers are also working to ensure that Megapacks are engineered to fully mitigate the risk of fire propagation from one unit to another under Victorian climatic conditions,” suggesting that propagation to the second Megapack may have been aided by weather factors such as wind, ambient temperature, and/or humidity. An investigation conducted by Fisher Engineering, Inc. confirmed that untested wind speeds were a key contributing factor, reaching up to 36 miles per hour during the event compared to a maximum of 12 miles per hour under the UL 9540A testing environment. In an interview, ESV characterized this situation as a “near miss” when considering an event like this in the context of other times of the year with higher temperatures and stronger winds.

The investigation identified some needed enhancements to procedures, firmware, and hardware. It also noted a clear and effective emergency preparedness and emergency response process involving several parties: the developer (via system designs), facility staff, subject matter experts, and emergency responders. In an interview, ESV shared lessons learned and stressed the importance of (a) regulator engagement in safety review from the time of installation and throughout operations, (b) a better understanding of an installation’s technology and its safety risks, and (c) a better understanding of interactions with the surrounding and natural environment.

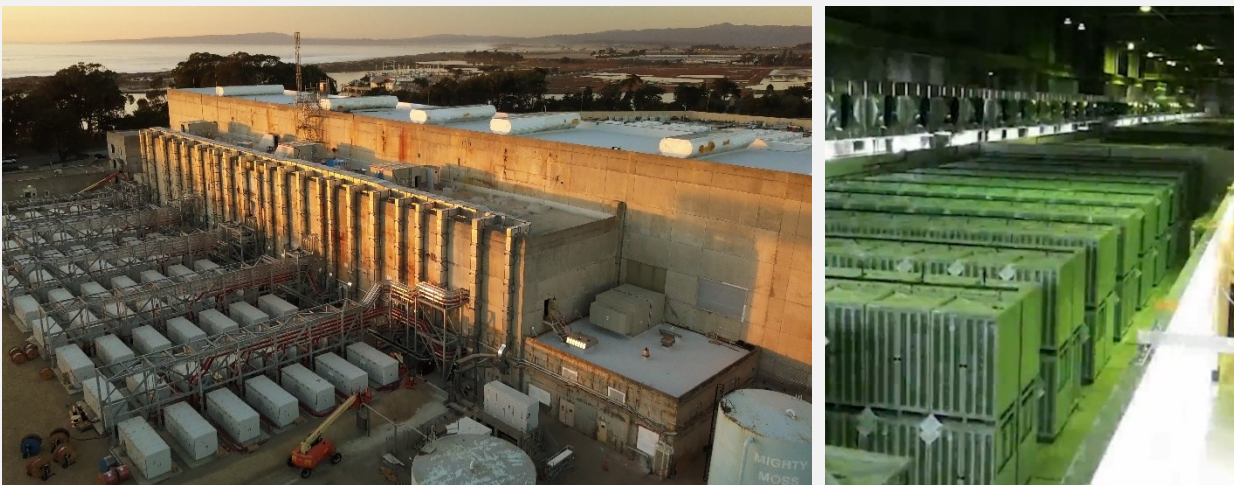
Figure 11: Moss 300 building exterior and interior.

In September 2021, the North County Fire Protection District of Monterey County responded to a fire alarm at the Moss Landing site (Principi 2021). When they arrived, no fire was present but battery modules in Moss 300 had overheated and were producing smoke. Hazmat and environmental teams were also called to the scene. After inspection of the situation, emergency responders determined that the batteries were not in thermal runaway and the smoke was originating from other materials surrounding the batteries as the batteries overheated. Seven percent of the battery modules were damaged (almost 7,000 modules, or almost 320 racks), along with other facility equipment. No injuries were reported. In February 2022 another similar safety event occurred at Vistra's adjacent Moss 100 site. Vistra reportedly postponed its Moss 300 reenergization until further investigations could be conducted. Vistra did not bring the Moss 300 project (mostly) back online until late June 2022 (Colthorpe 2022)—almost a year after the September 2021 incident.

After a 5-month investigation, in January 2022, Vistra released a statement describing the facility, incident findings, and corrective actions (Vistra 2022). Vistra described the origin of the event as the combination of (a) a source of smoke at or near the facility's air handling unit and (b) due to a programming error, an overly-sensitive Very Early Smoke Detection Apparatus (VESDA) that was prematurely triggered. After the fire suppression sprinkler system activated, hose and pipe leaks sprayed water directly onto battery racks. Water also leaked from the upper floor onto battery racks on the lower floor. This type of water exposure caused short-circuiting and arcing, battery damage, and more smoke—which then led to continued VESDA activation.

Vistra's corrective actions include complete pressure-testing of the water delivery system, installation of a system to monitor for water leaks, VESDA re-programming, installation of smoke detectors in all air handling units, and sealing gaps in the facility's upper floor.

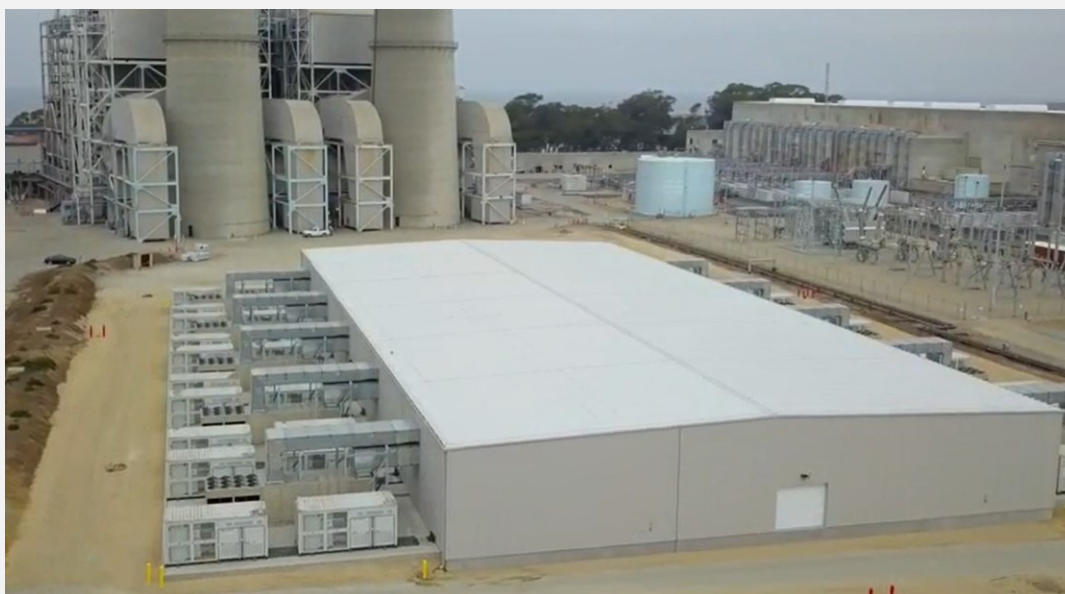
Figure 12: Moss 100 building exterior.

In February 2022, the North County Fire Protection District of Monterey County again responded to an emergency call at the Moss Landing site (Principi 2022). No fire was found at the scene. This time, emergency responders found the Moss 100 fire suppression system was activated and spraying water. Vistra shut down the facility pending investigation and repairs, then brought it back online in late June 2022 along with the Moss 300 project—5 months after shut down. No injuries from the incident were reported.

At the time of this report, the exact cause is not yet publicly clear. A Vistra statement (Vistra 2022) and news reports indicate that the cause may be similar or the same as the September 2021 safety event at Moss 300. Something triggered the facility's smoke detection equipment which was apparently overly sensitive due to a programming error. Then, apparently (but to be confirmed): the fire suppression system activated and sprayed water, water contacted the batteries due to water hose leak(s), which then caused the batteries to overheat, and surrounding materials released smoke as they melted/scorched.
